Maintenance Program Assessment

Lambeau Field
Green Bay, Wisconsin

December 2024

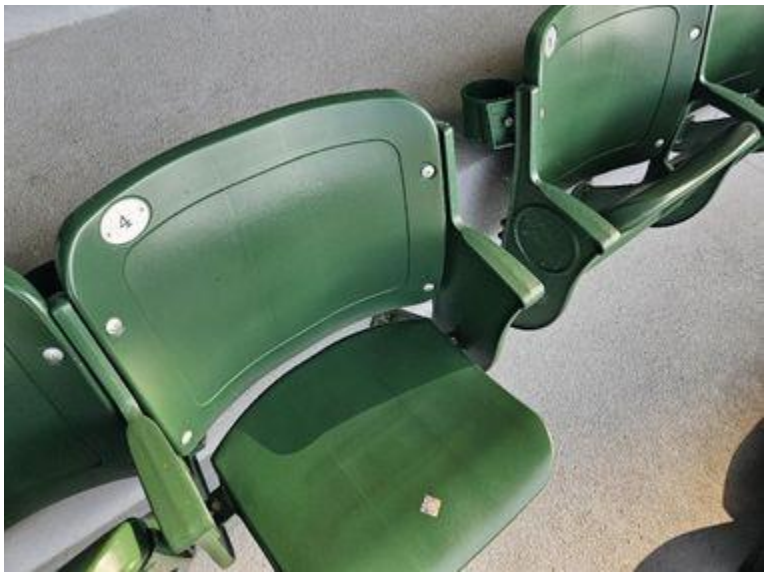
600 Level-Section 641S

Sticker

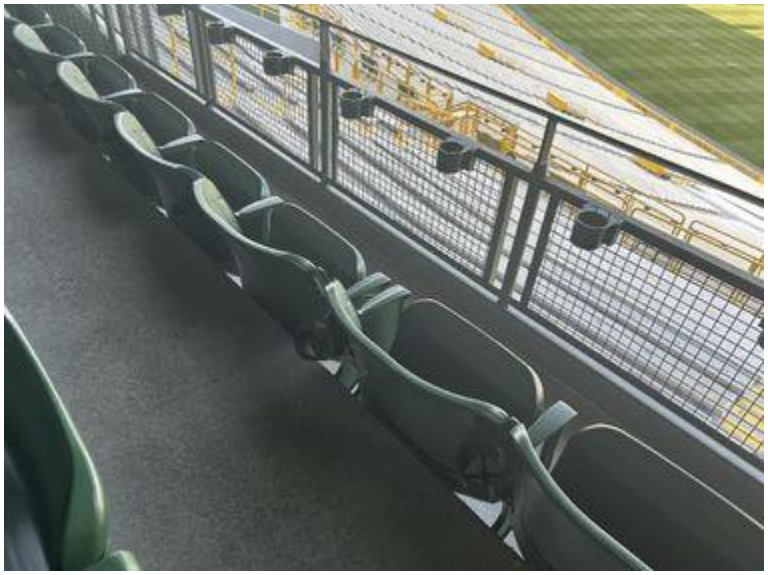
600 Level-Section 672
Finishes

Item Description
Broken cup holder

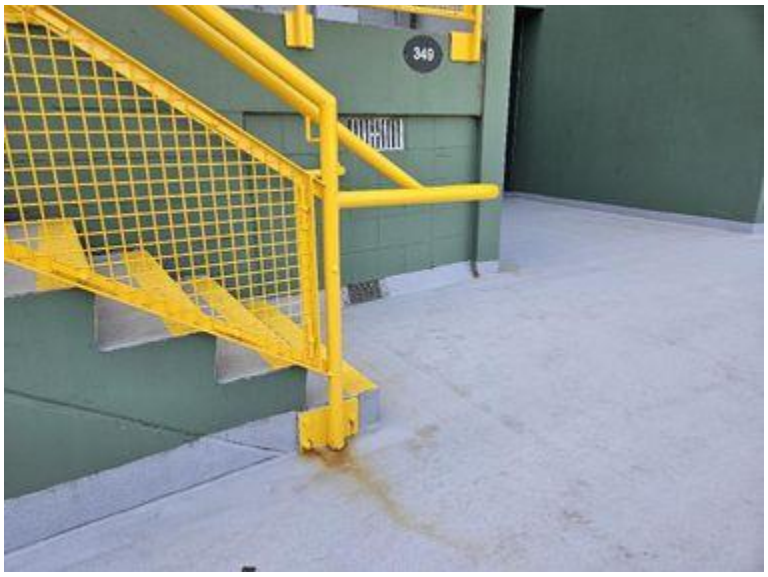
300 Level-Section 305

Handrail corroding

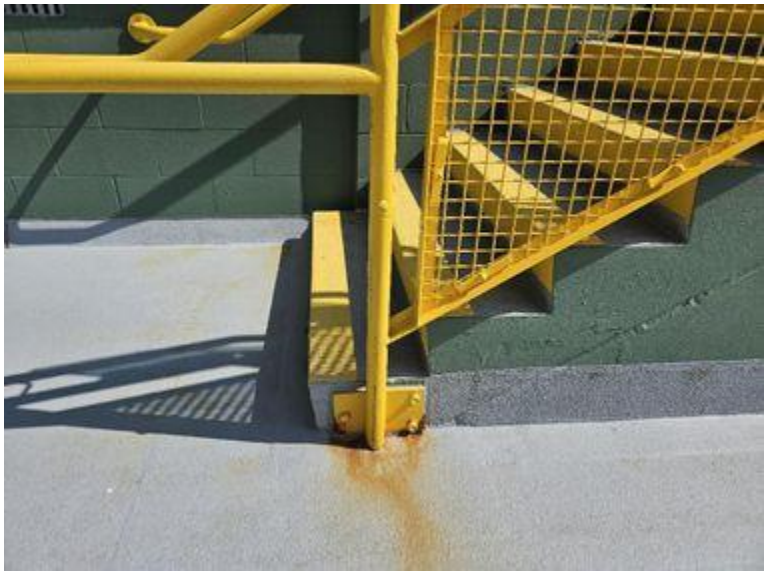
300 Level-Section 307

Handrail corroding

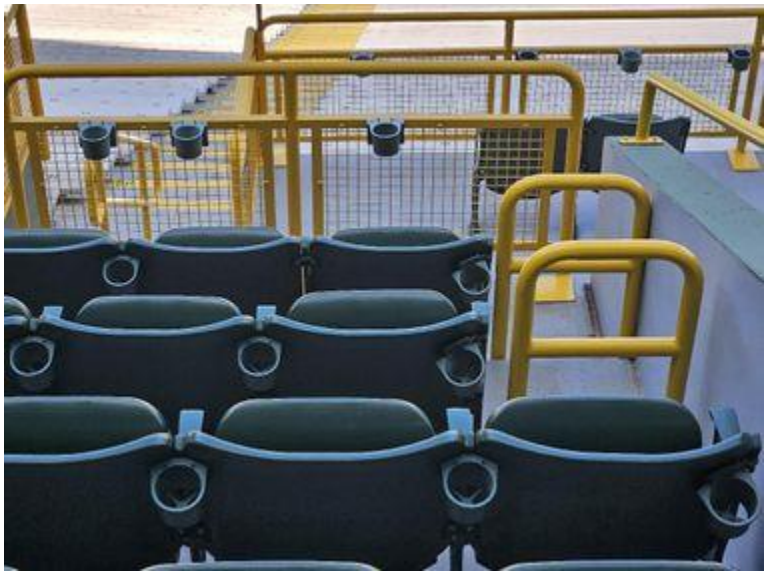
400 Level-Section 419

Missing cupholder

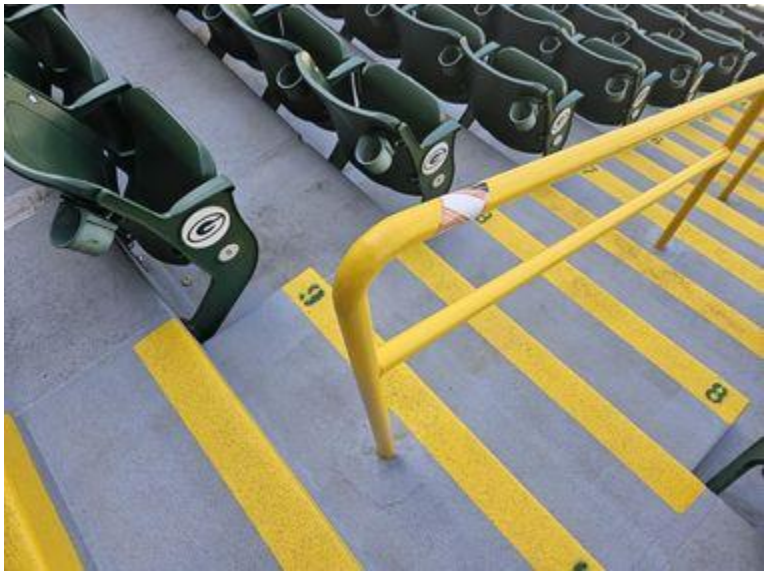
400 Level-Section 407

Sticker

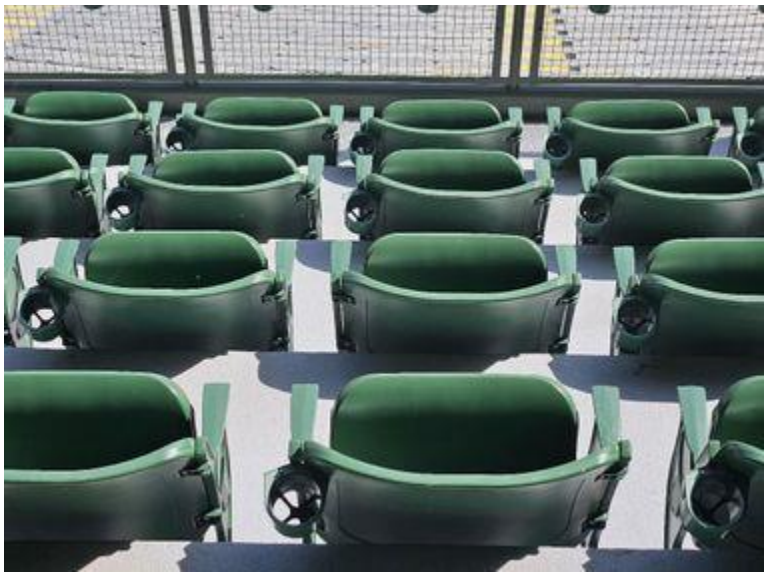
700 Level-Section 734S

Missing cupholder

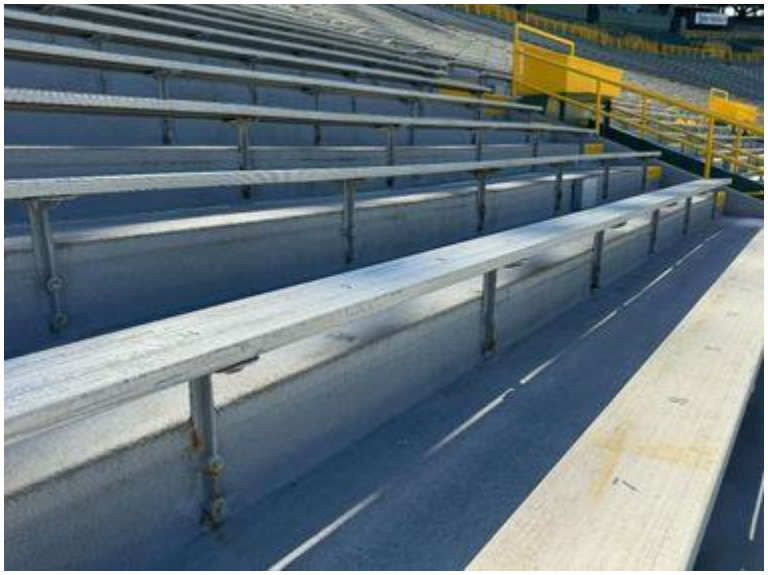
100 Level-Atrium Meat Packing

Sticker

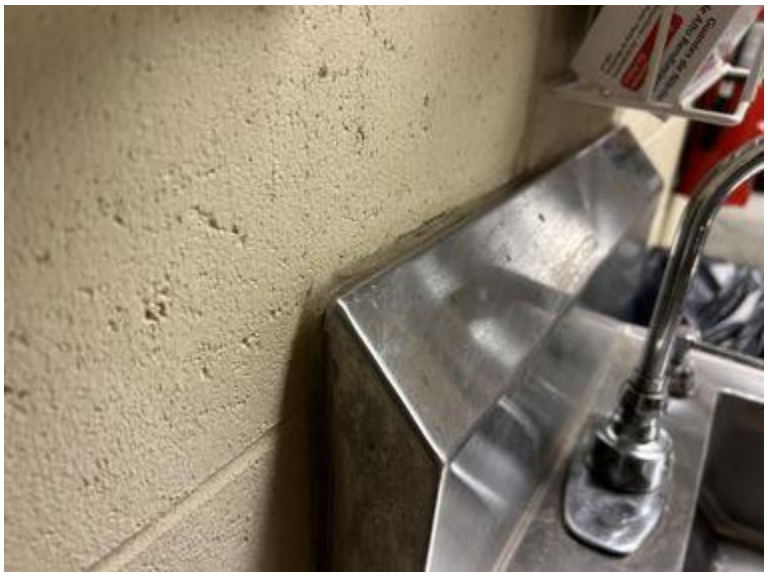
100 Level-Room 132-I
Plumbing

Item Description
Sealant failing

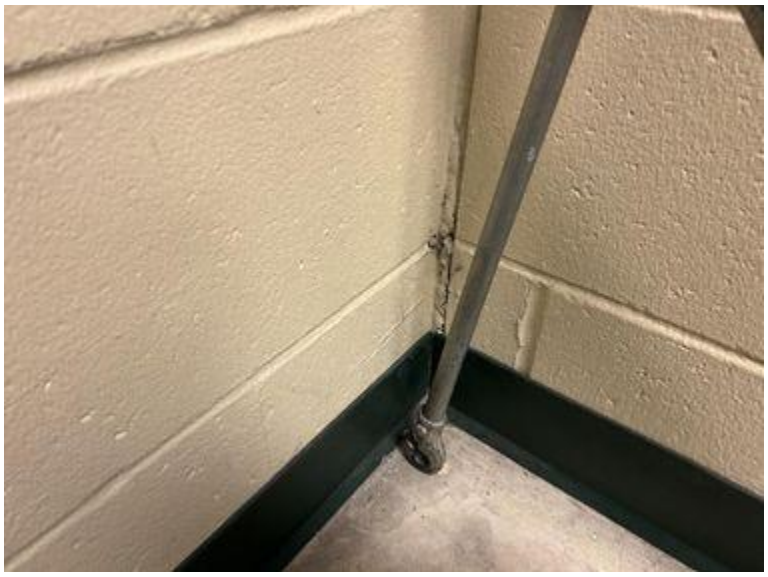
100 Level-Room 105-I

Sealant failing

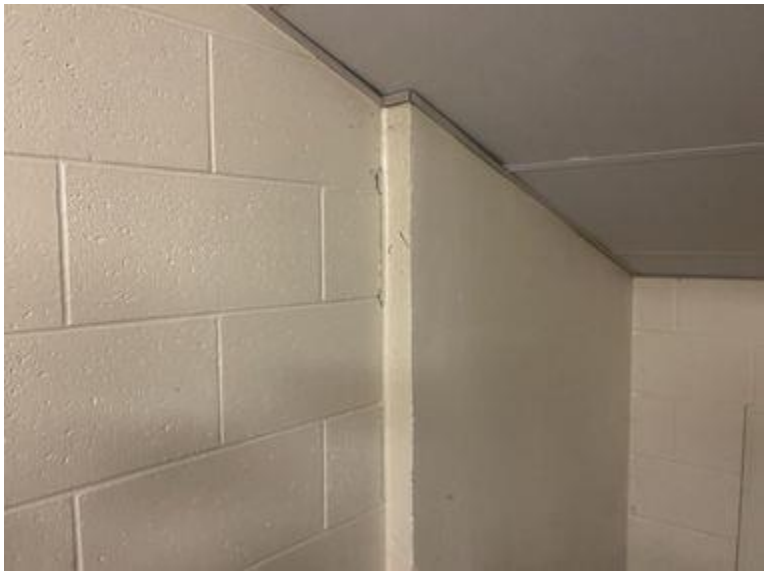
100 Level-Room 115-I

Mortar cracking

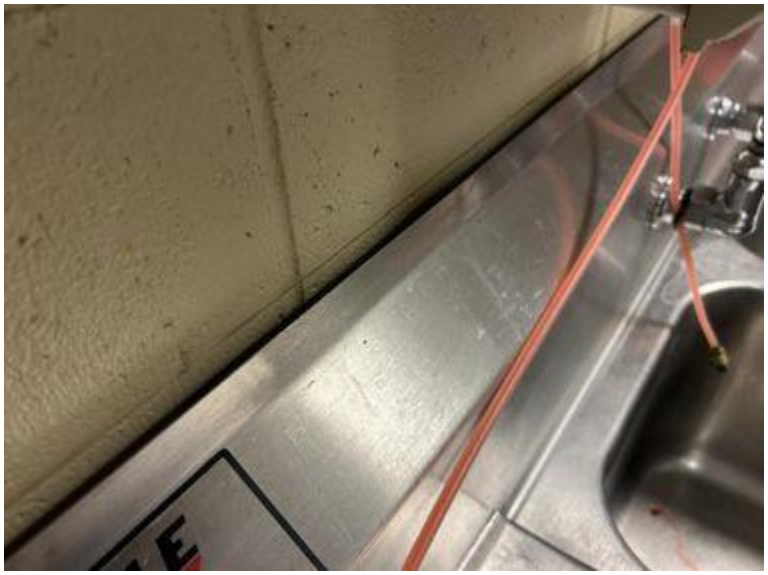
100 Level-Room 115-I

Sealant missing

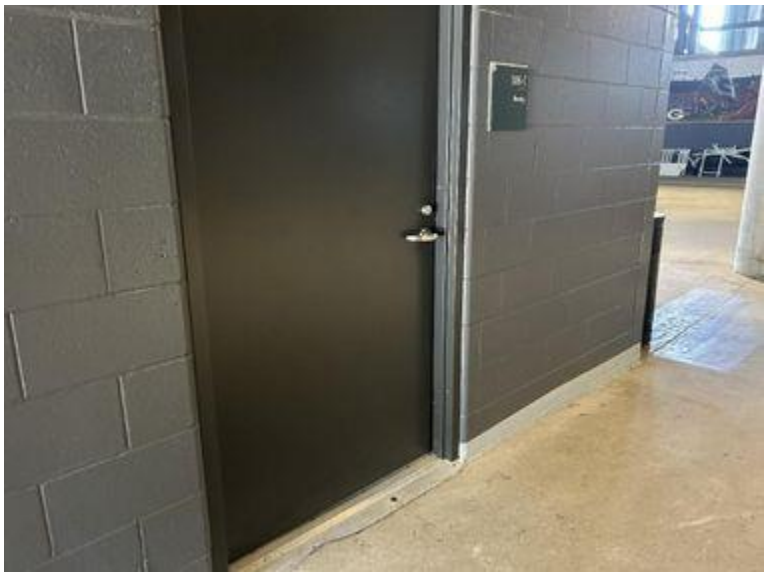
100 Level-The Legacy Zone - Oneida
Masonry

Item Description
Concrete spalling

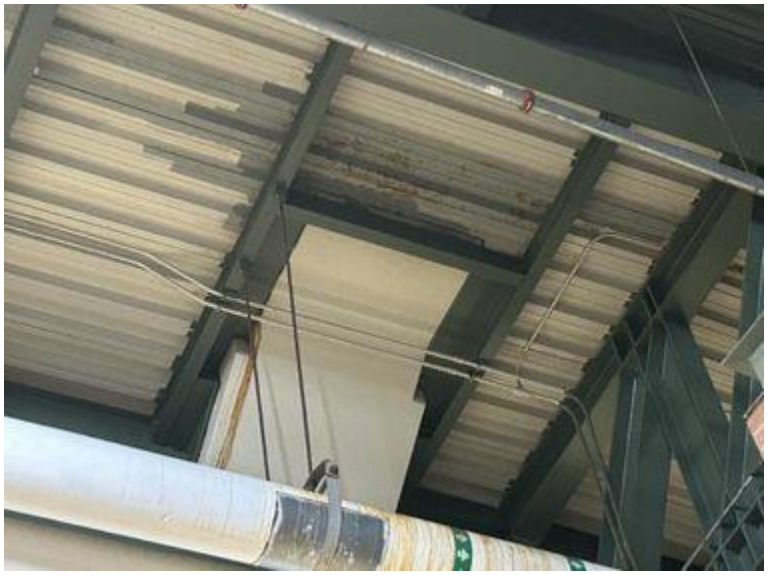
100 Level-Section 123/121
Miscellaneous

Metal deck corrosion from 300 level

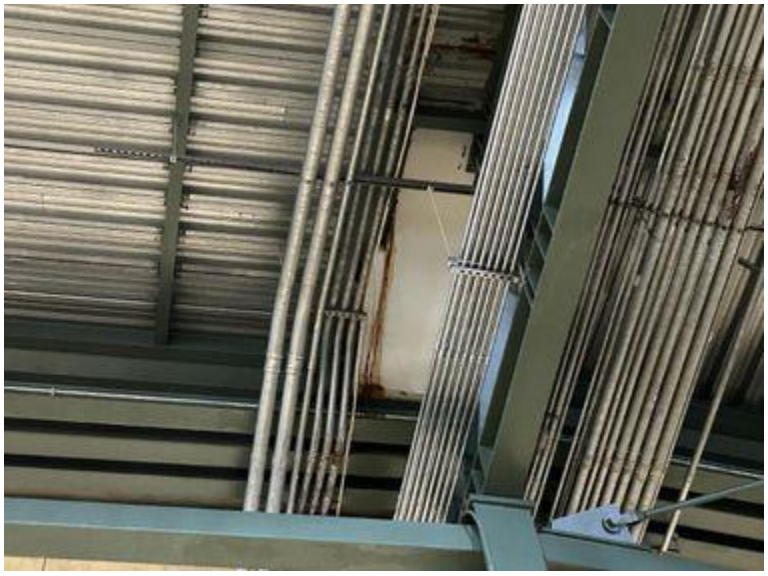
100 Level-Section 131
Metal

Corroding stairs from 300

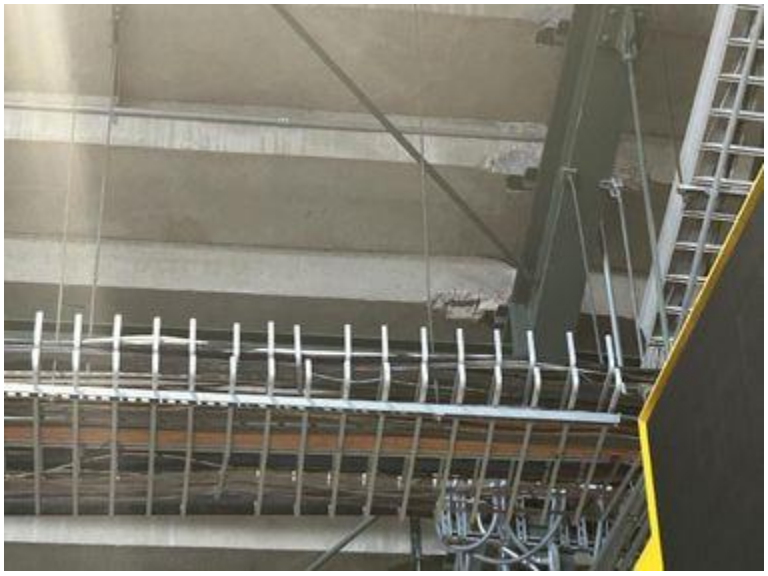
100 Level-Section 104
Marketplace
Sealant

Concrete spalling

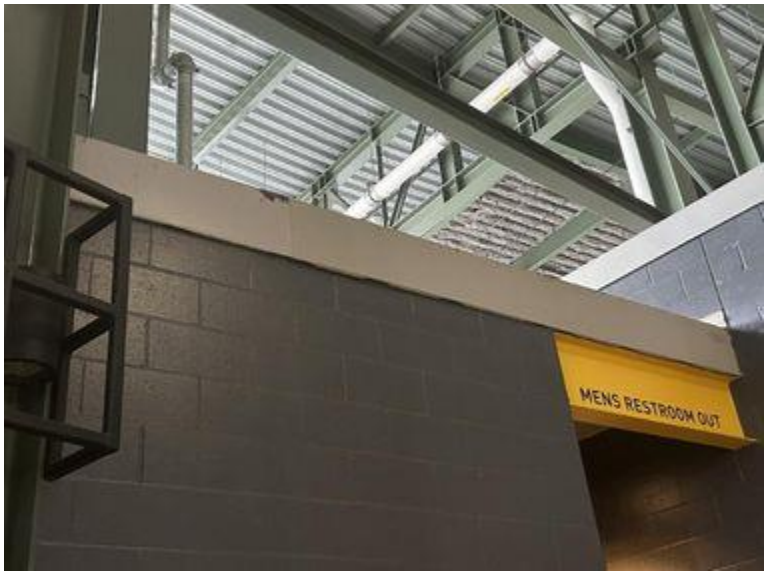
100 Level-Section 102

Item Description
Corroding flashing

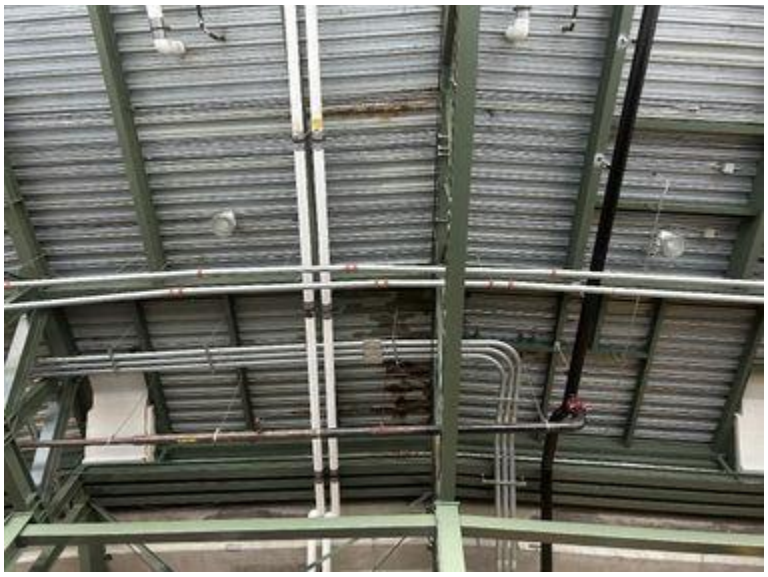
100 Level-Section 111

Corroding metal deck

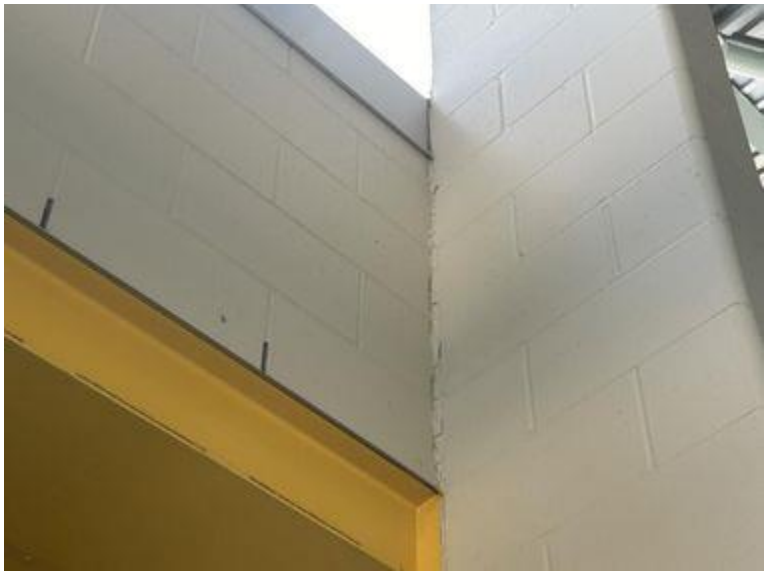
700 Level-Room 7C03
Corrosion

Paint peeling at sealant

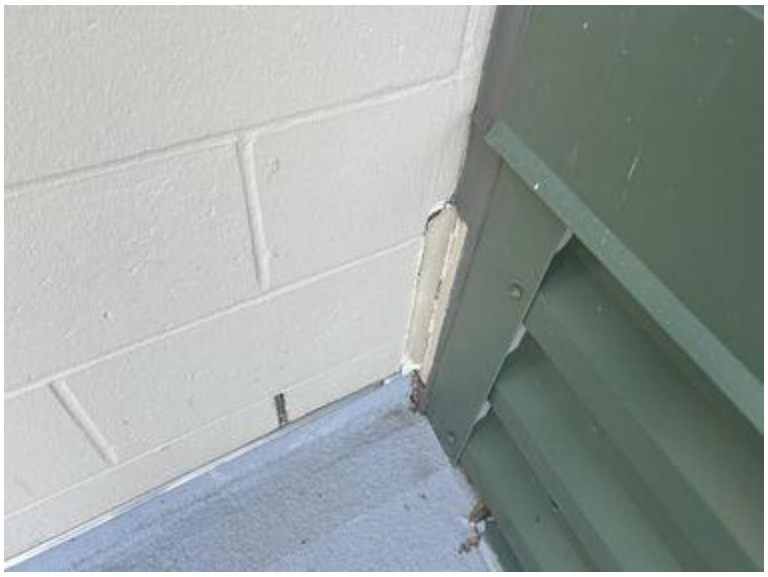
700 Level-Room 734S

Sealant failing

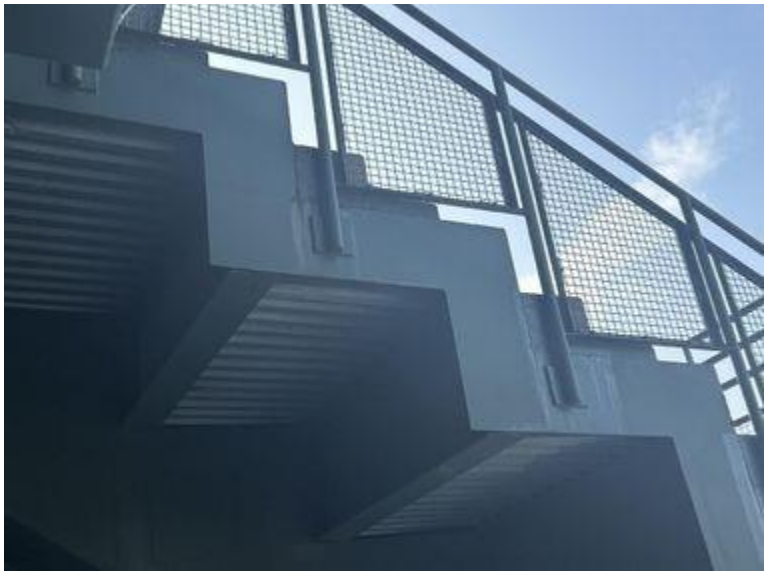
400 Level-Room 438S
Painting

Item Description
Steel corroded

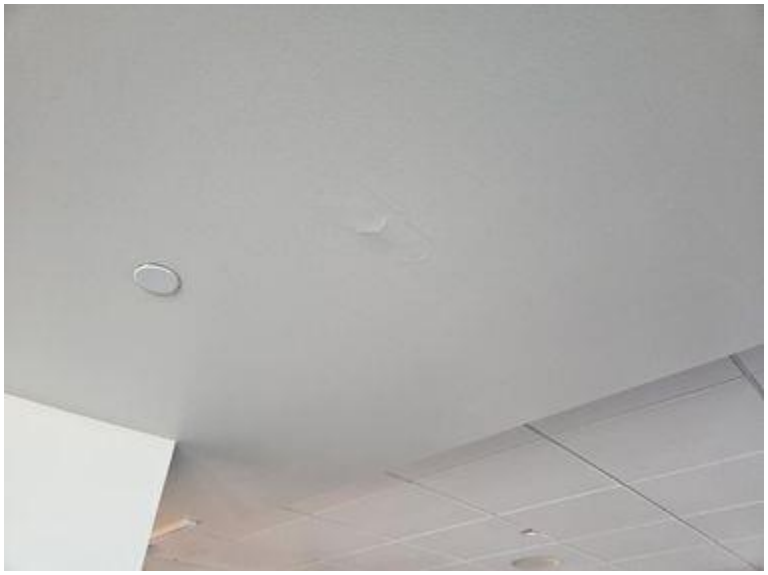
400 Level-Section 492

Drywall cracking

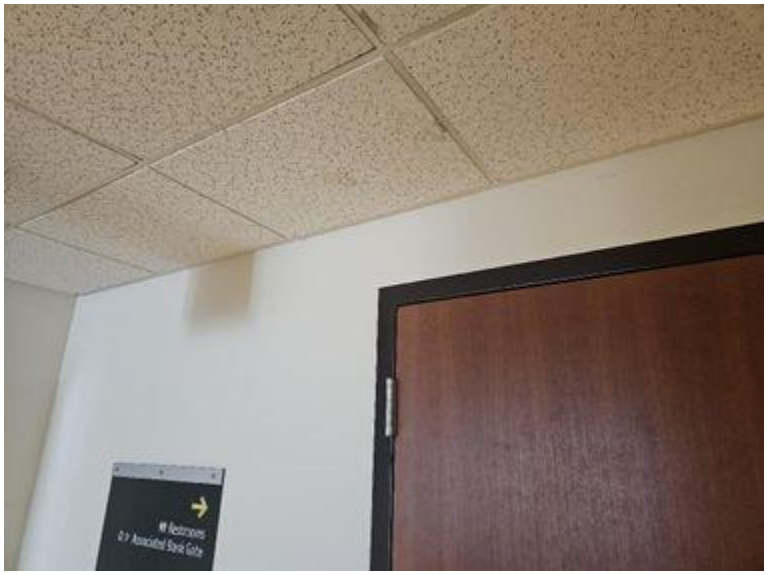
Service Level-Near LC14C

Stained ceiling tile

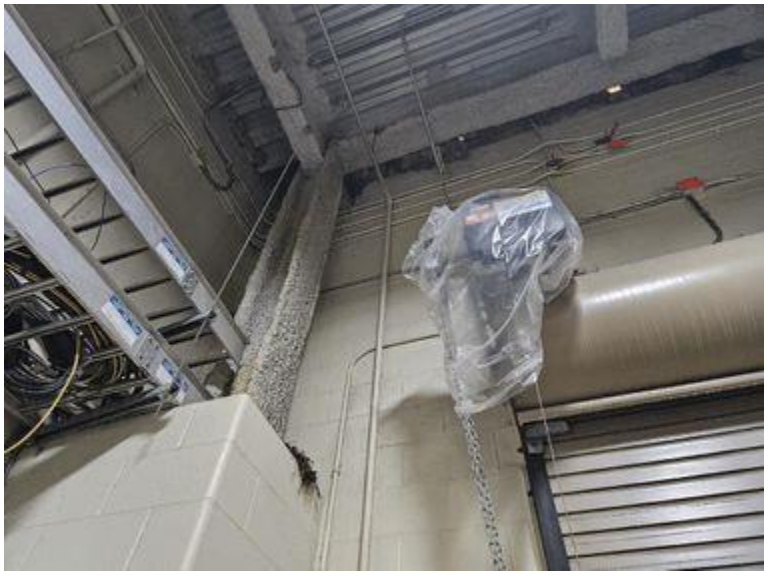
Item Description
Birds nesting

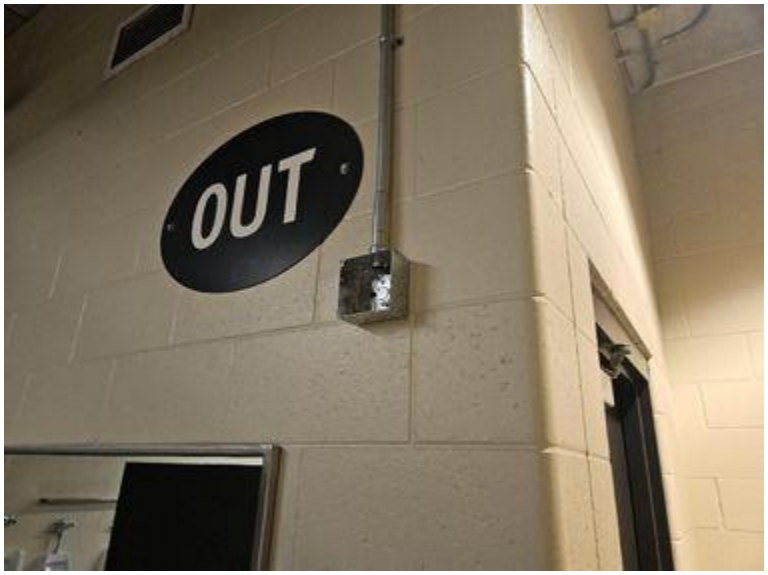
100 Level-Section 129
Men's Bathroom
Electrical

Open junction box

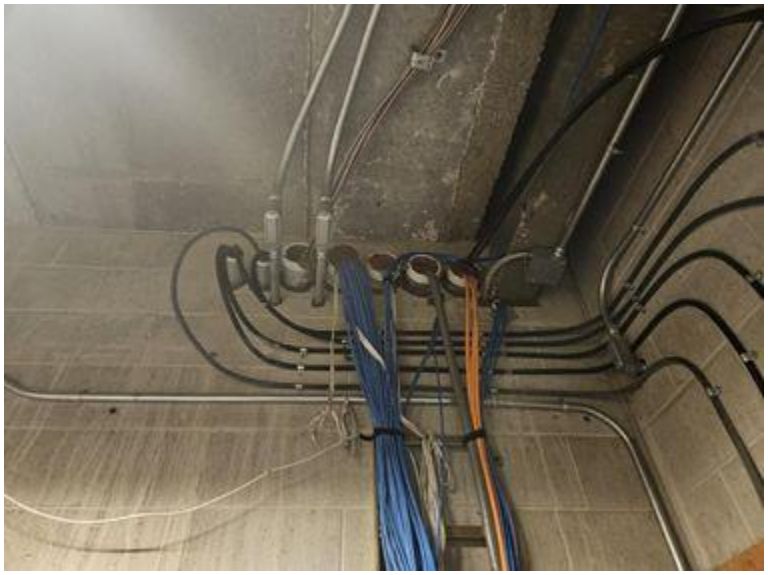
100 Level-Room 1E35

Fire stopping missing

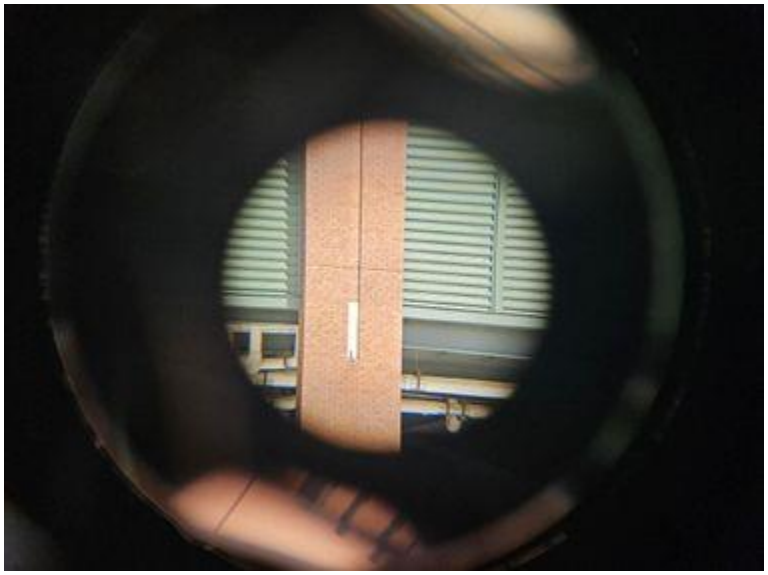
400 Level-Invisalign Gate
Sealant

Corrosion staining

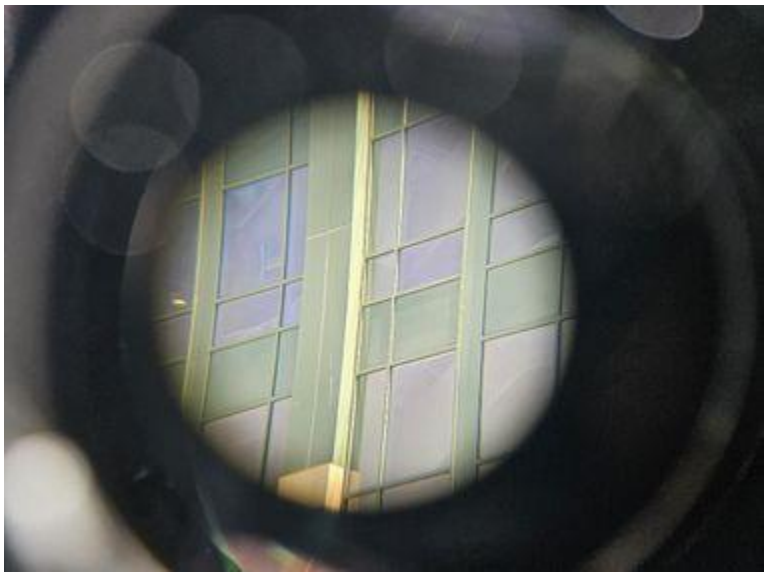
100 Level-Invisalign Gate
Building Envelope

Item Description
Sealant failing

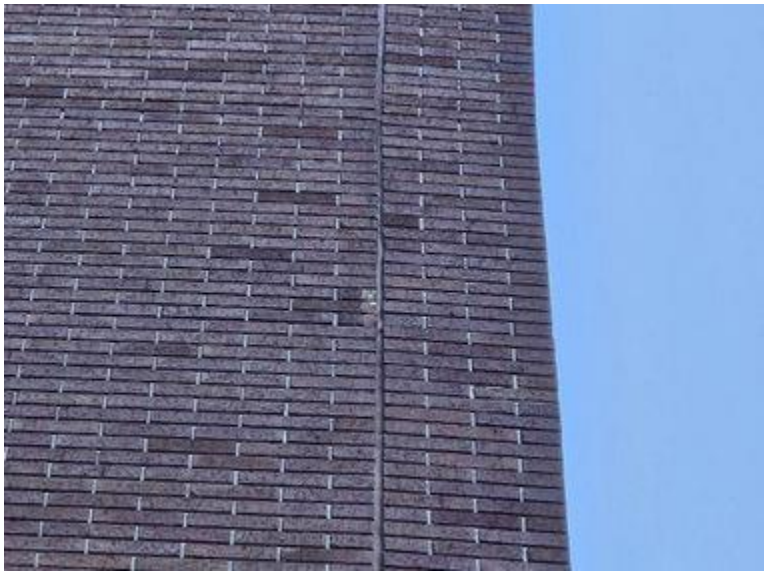
Brick flaking

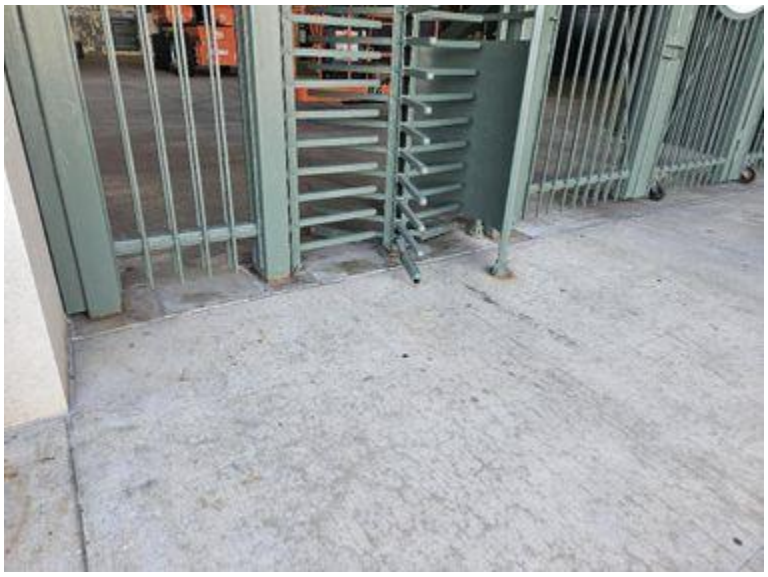
100 Level-Bellin Health Gate

Gate and fence corroding

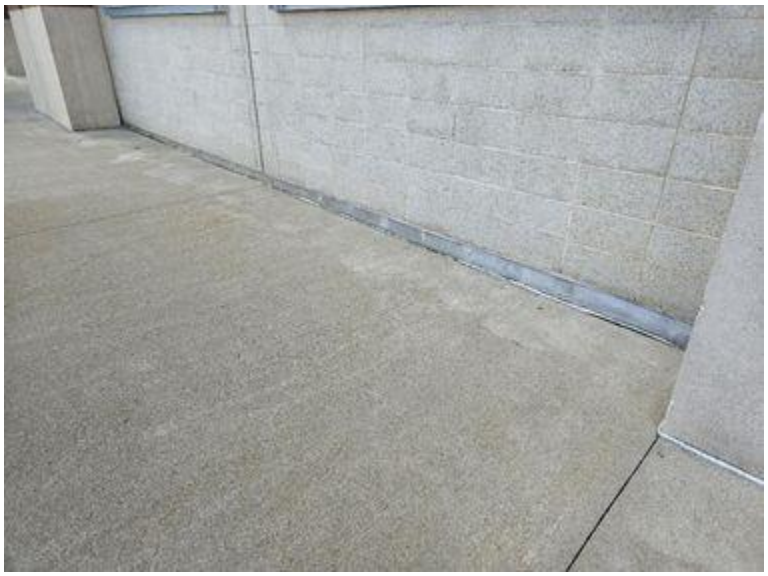
100 Level-Atrium Plaza
Sealant

Sealant failing

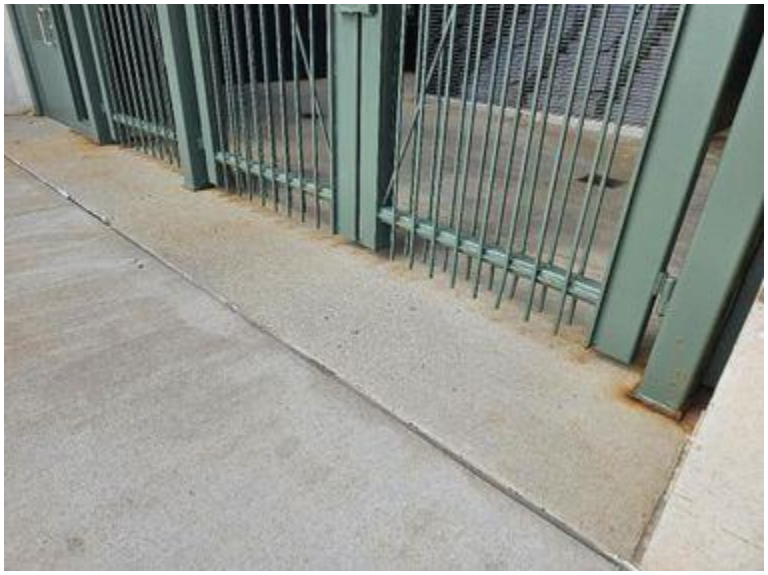
100 Level-Pro Shop

Gate and fence corroding

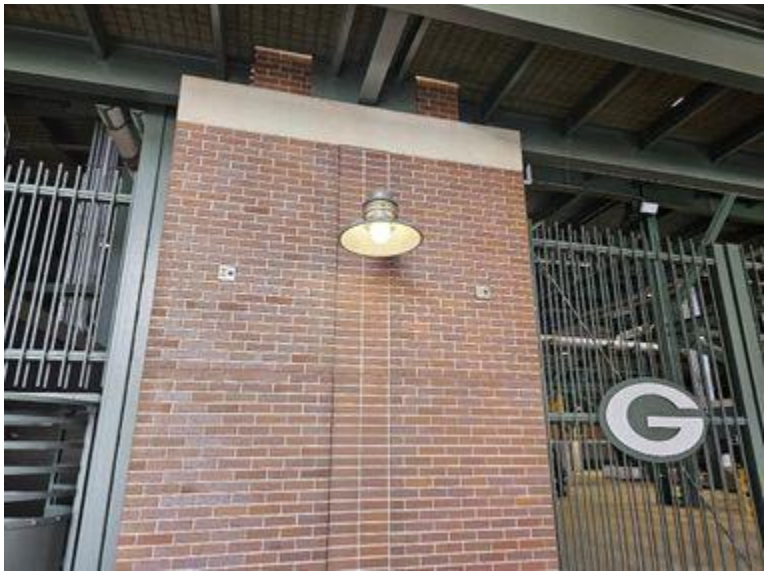
GFI outlet and cover needed

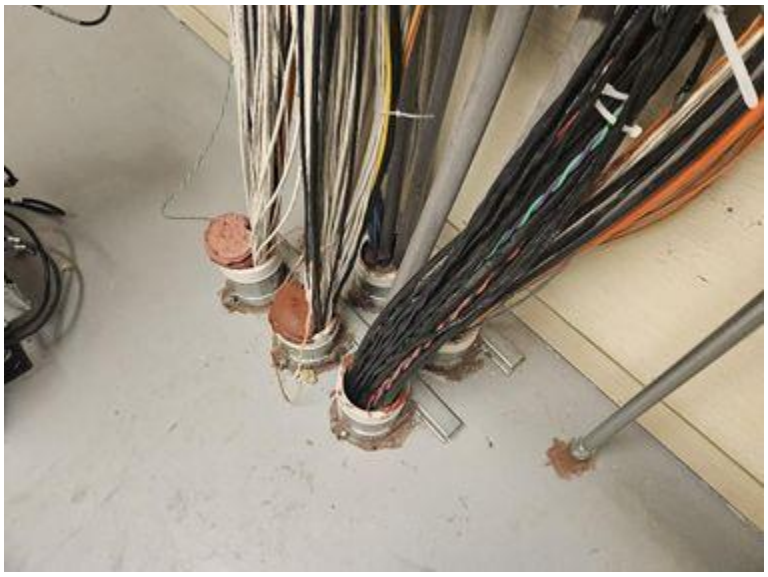
Service Level-Freight Elevator
Fire Protection

Item Description
Firestop missing

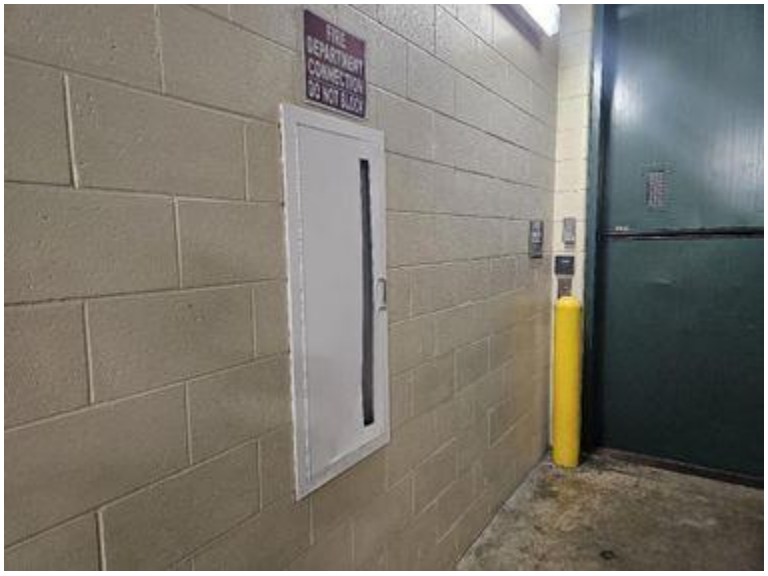
100 Level-Section 136
Women's Bathroom
Sealant

Item Description
Fire cabinet damaged

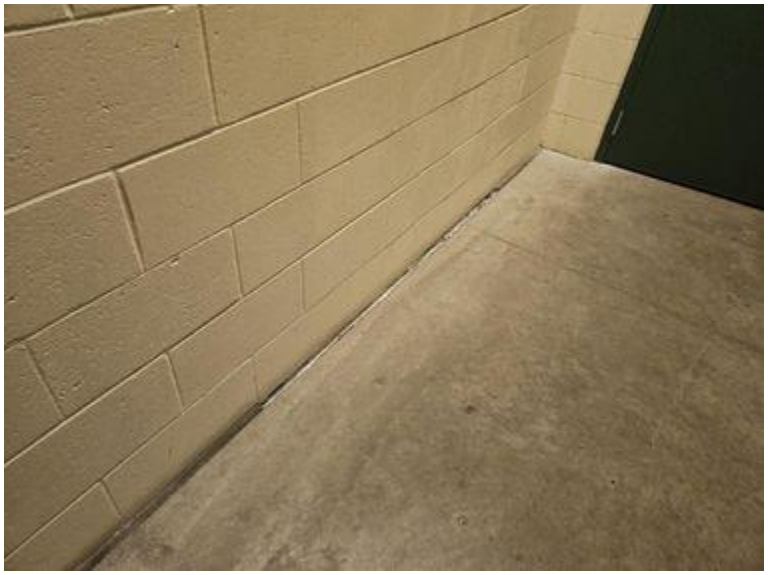
100 Level-Room 1C00B
Masonry

Item Description
Missing sealant

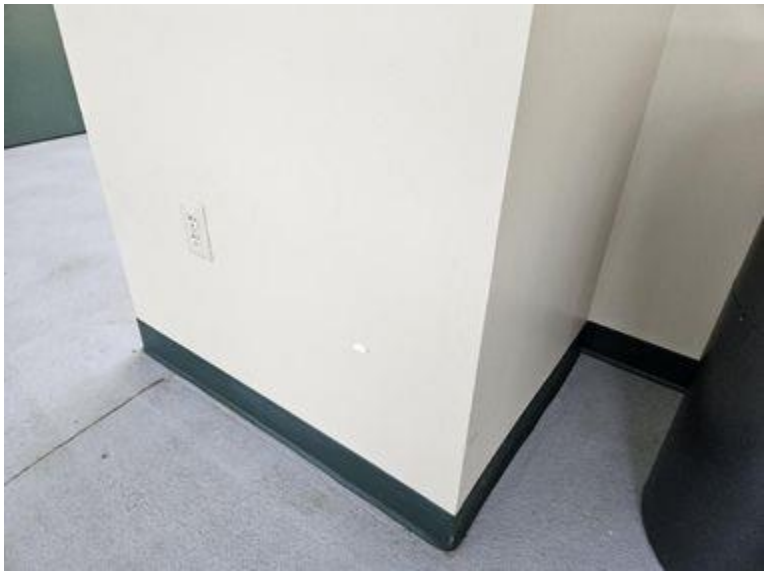
400 Level-Room 440S
Finishes

Drywall damage

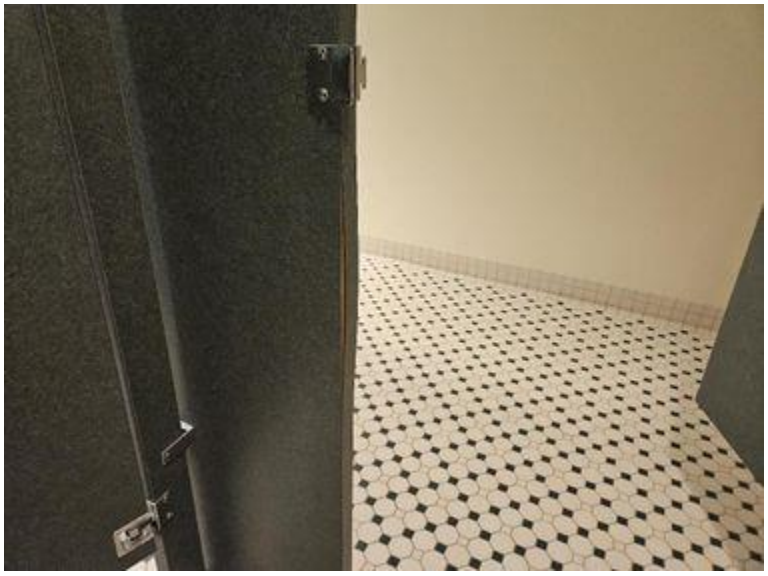
600 Level-Men's
Bathroom by Suite 6063
Finishes

Item Description
Laminate separating

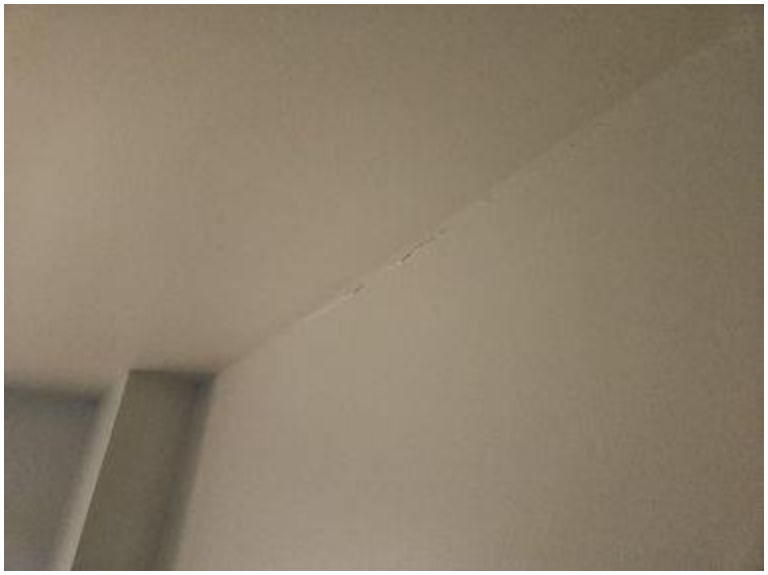
600 Level-600 Level by Suite 6003
Finishes

Drywall cracking

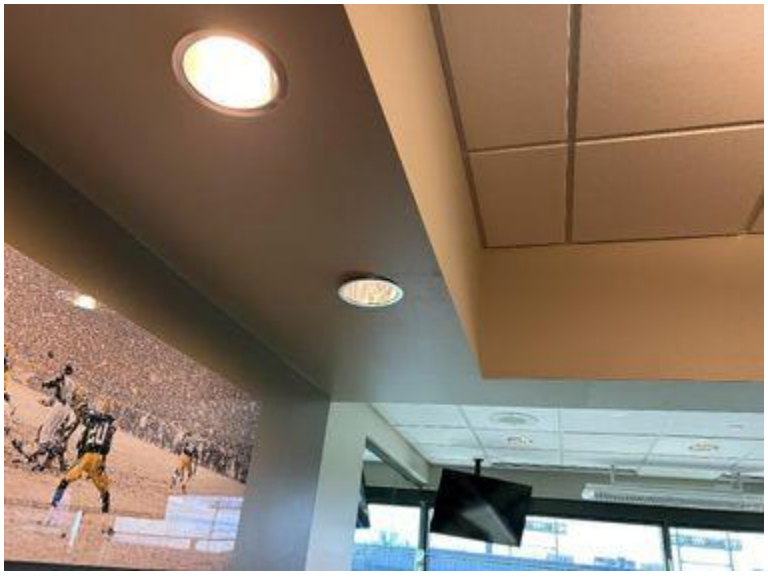
600 Level-Suite 6043

Item Description
Can light rim not flush

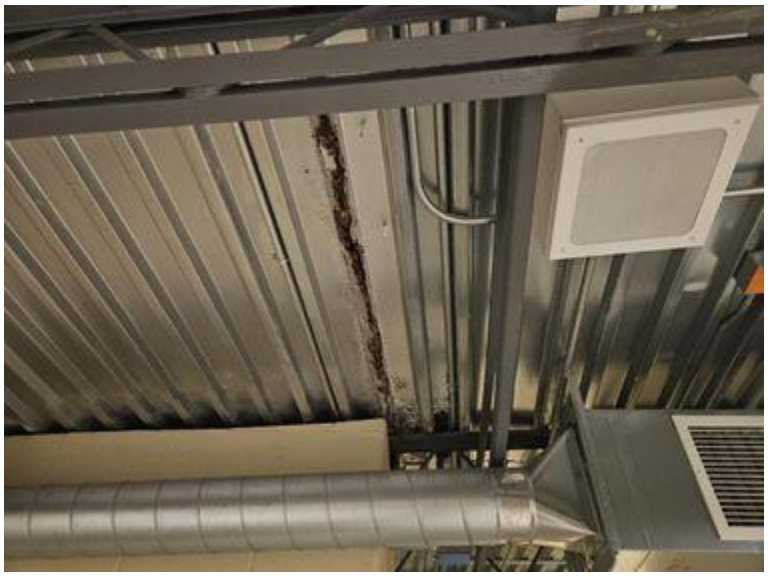
300 Level-Room 3C09

Floor pan corroding

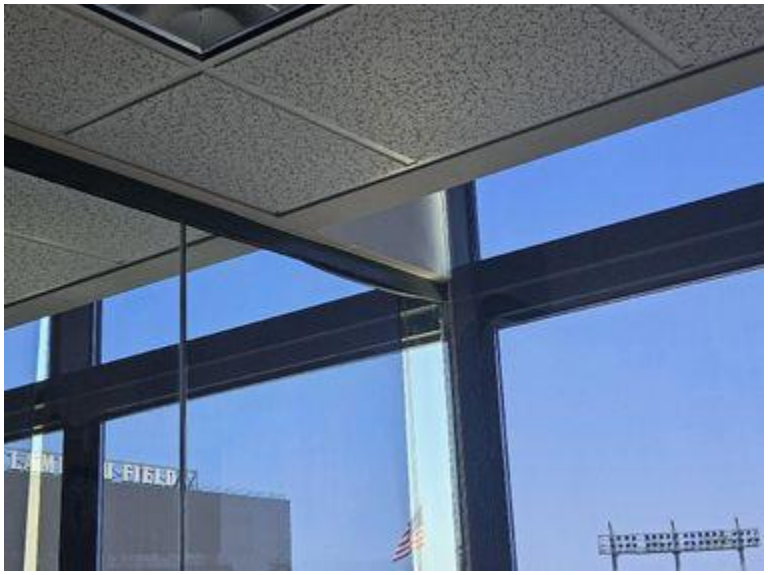
Window gasket dislodged

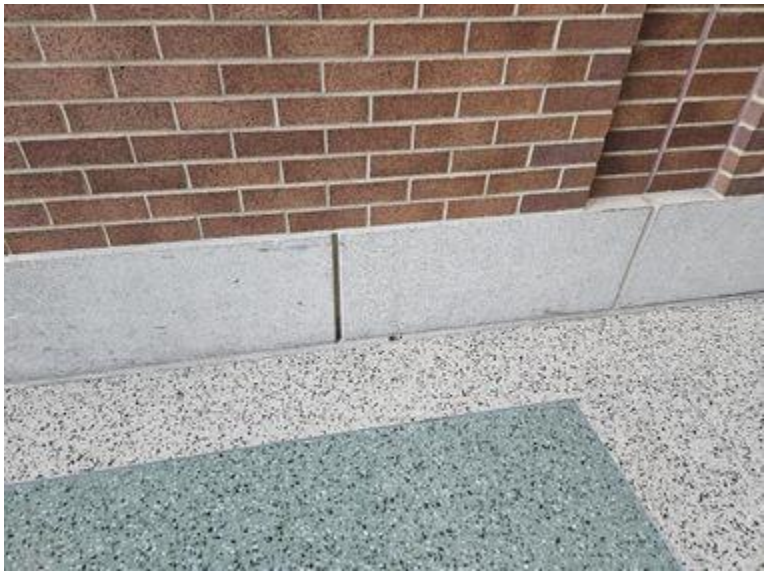
100 Level-Atrium-Plaza Entrance

Sealant failing

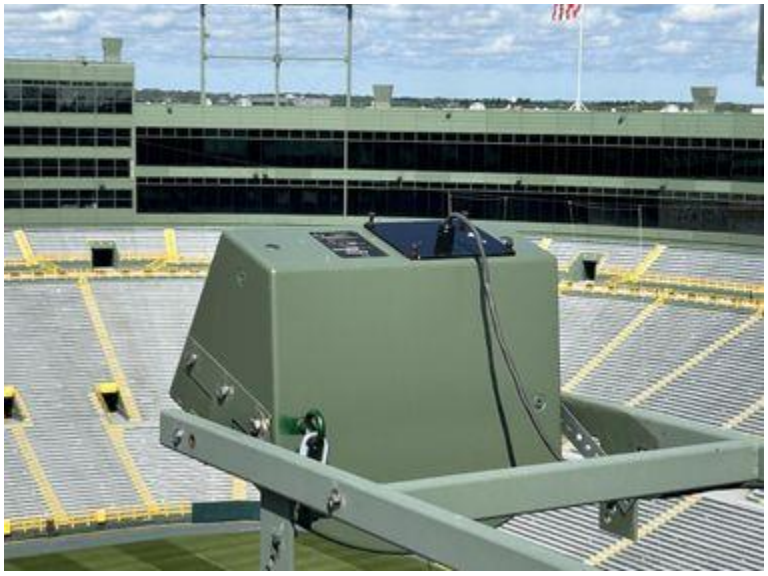
Speaker plate not fully secured

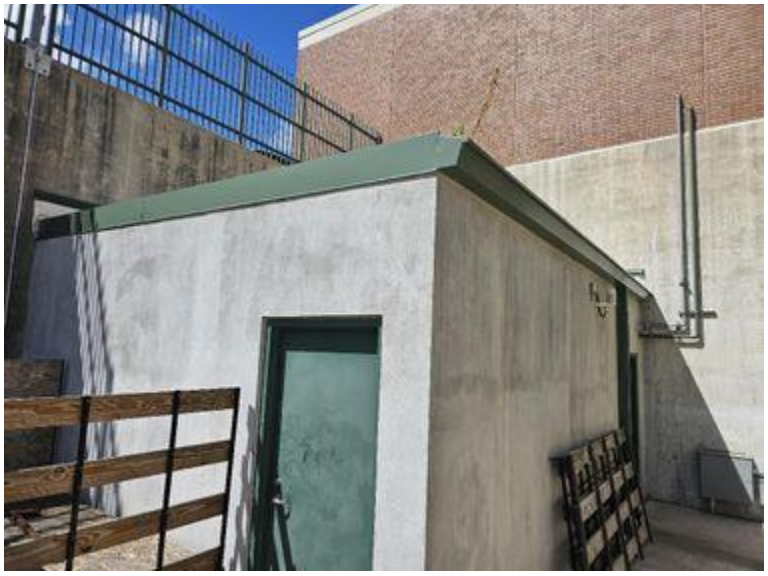
Plant growing

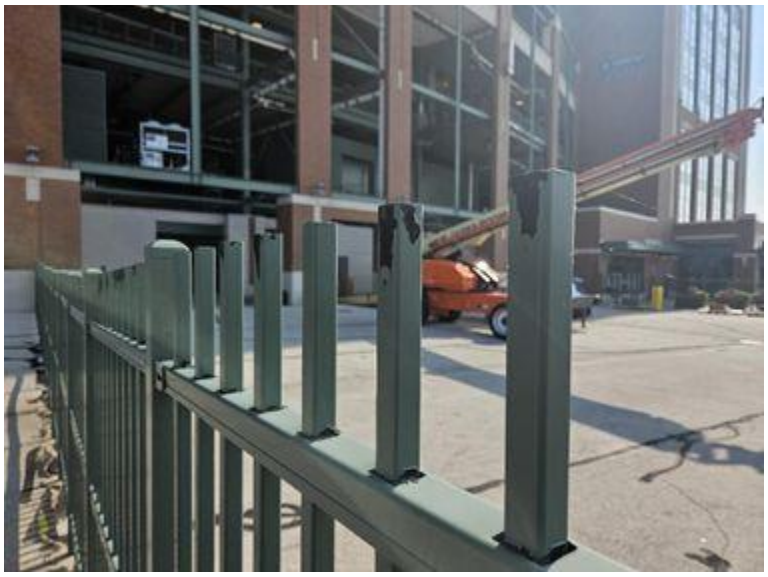
Paint peeling

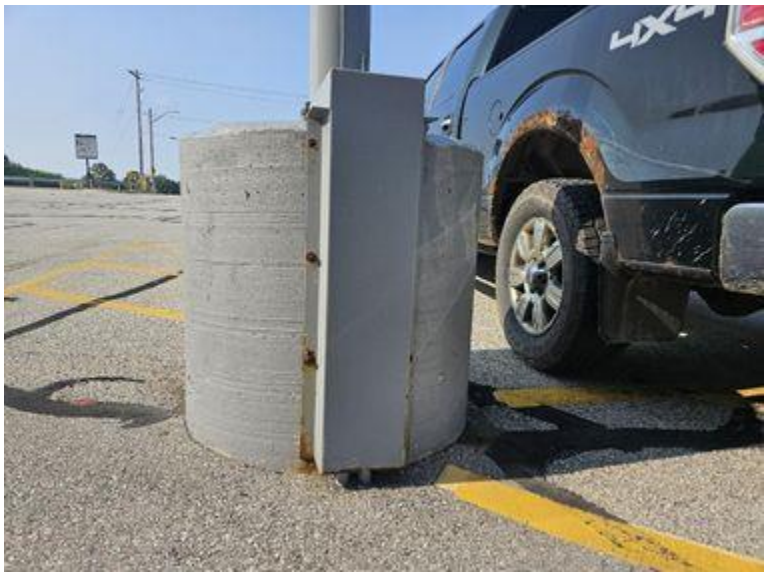
-Lot 7

Steel corroding

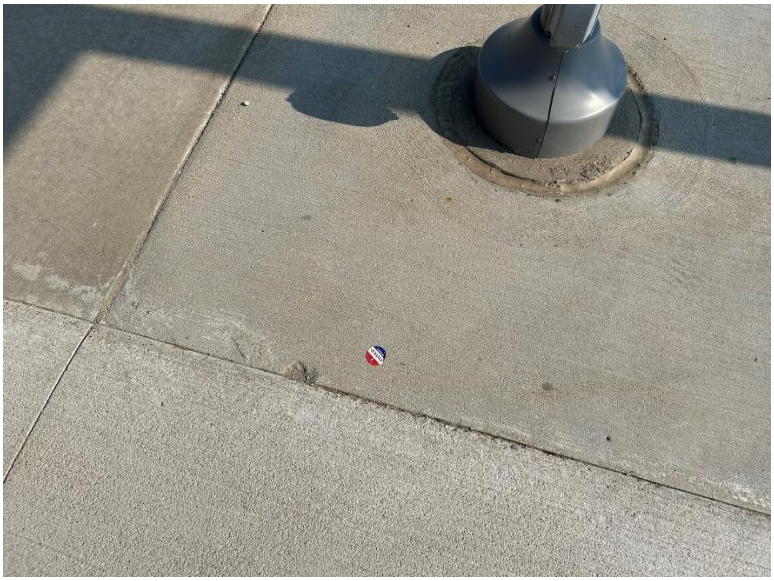
-Harlan Plaza Stair

Concrete cracking

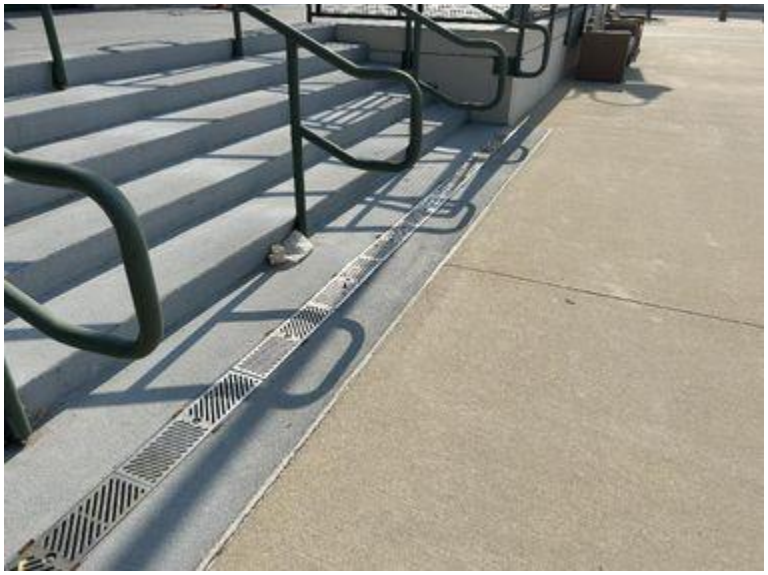
-Tailgate Village Plaza

Sealant failing

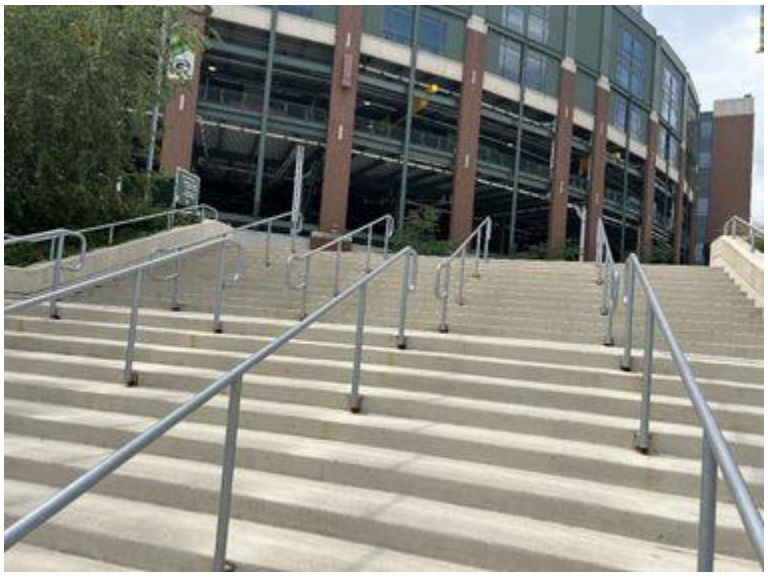
-Harlan Plaza

Corroding brackets

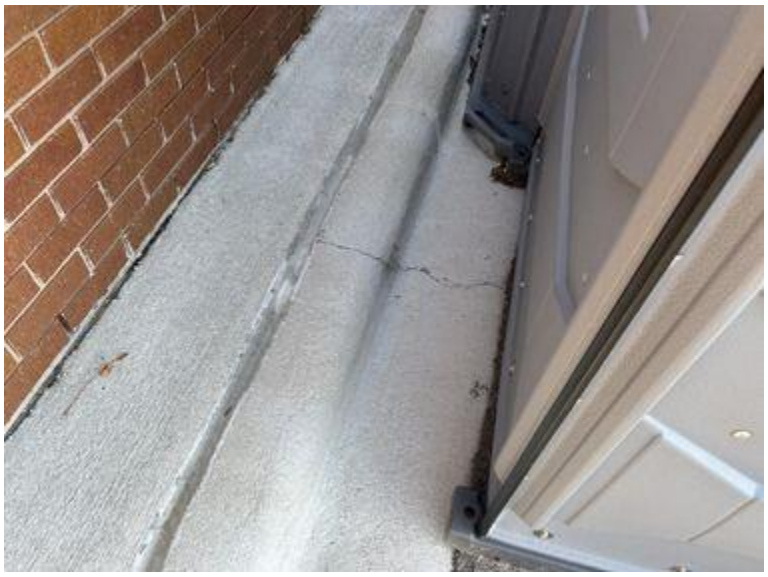
-Lot 1

Concrete cracking
