Maintenance Program Assessment

Lambeau Field
Green Bay, Wisconsin

December 2024

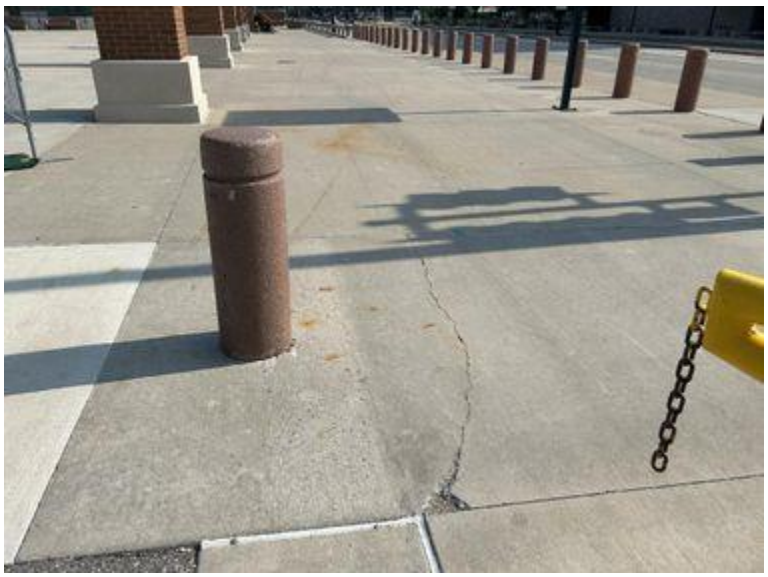
-Lot 1

Concrete cracking

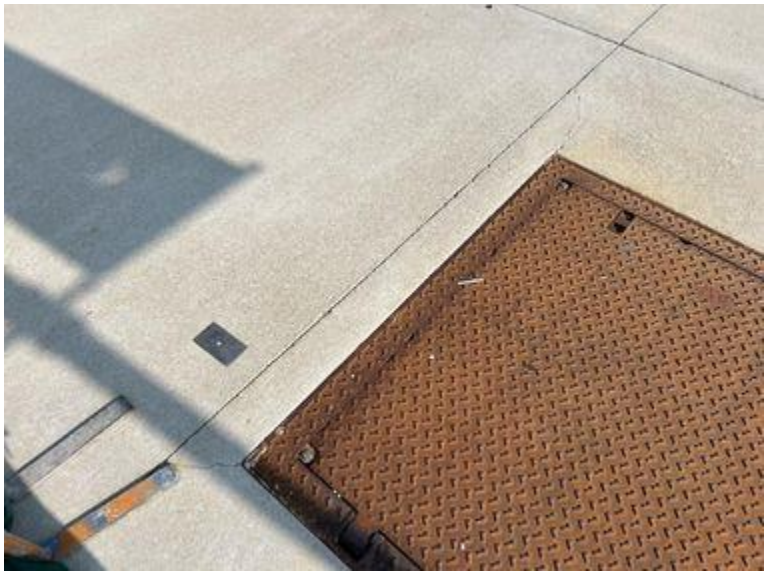
-Tailgate Village Plaza

Concrete cracking

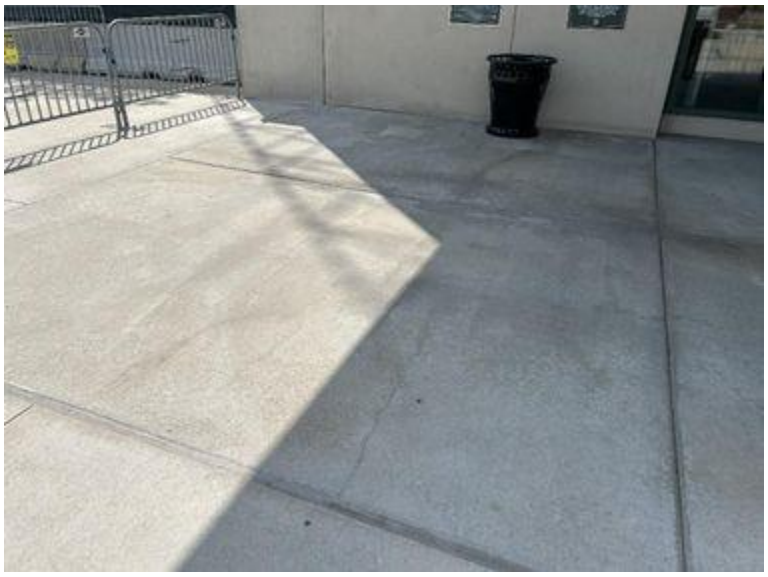
-Pro Shop Entrance

Concrete cracking

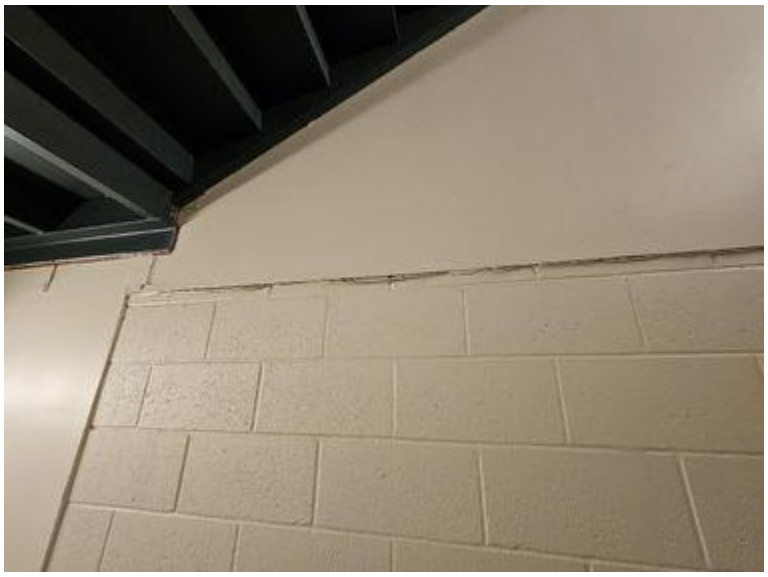
400 Level-Stair L

Sealant failing

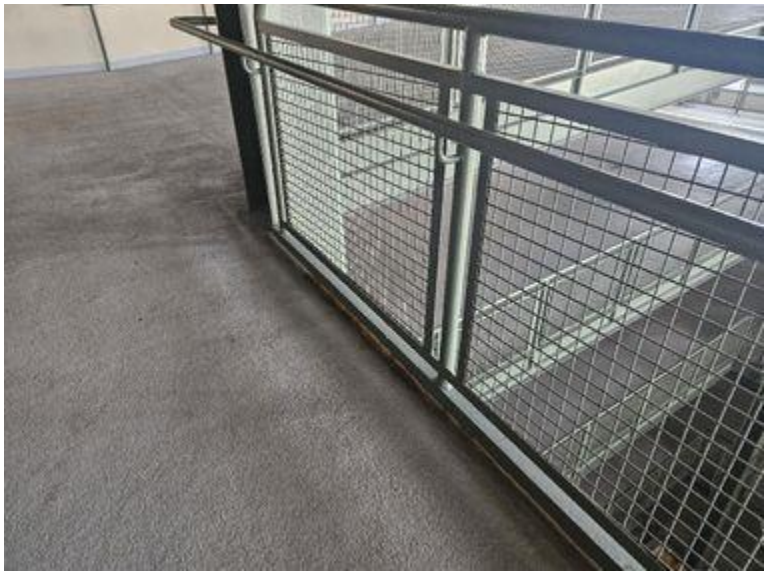
100 Level-Oneida Ramp

Handrail corroding
